National Transportation Safety Board

**Addendum 1 to the Survival Factors Group Chairman Factual Report**

**El Faro DCA16MM001**

**Survival Equipment Mentioned in VDR Transcripts**

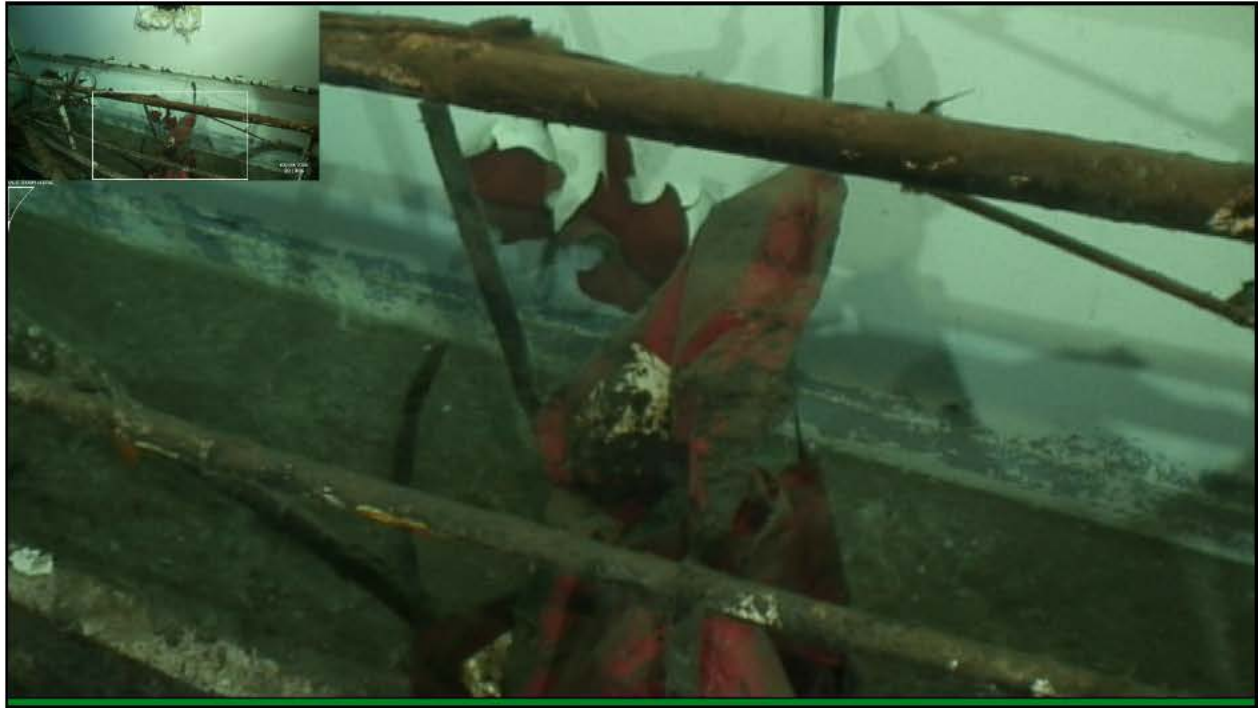
**Figure A1-11.** Life preserver, or personal flotation device (PFD), with reflective material discovered on *El Faro*'s aft boat deck walkway rail, starboard of centerline. Still photo taken on third VDR search mission by remotely operated vehicle CURV-21 and time-stamped 8/9/2016 09:10:06.
